FLOOD PLAIN MANAGEMENT STUDY  
for the  
**PALOMINAS-MIRACLE VALLEY AREA**  
Cochise County, Arizona

Prepared by the  
**United States Department of Agriculture**  
**Soil Conservation Service**  
In cooperation with the  
**Hereford Natural Resource Conservation District**  
**Cochise County**  
**— Arizona Department of Water Resources**

AUGUST 1987

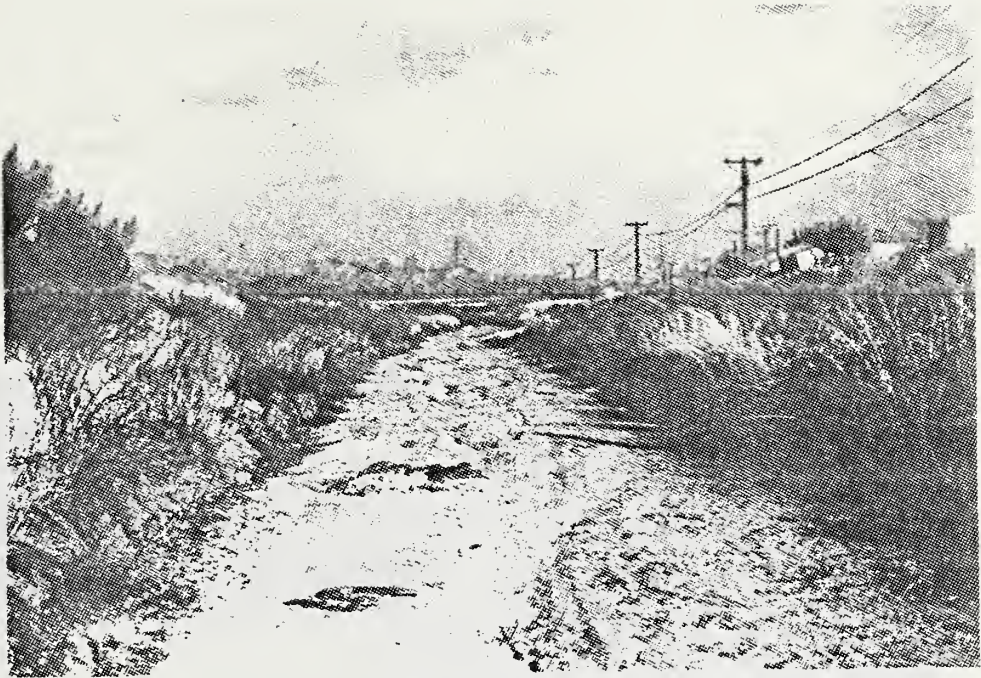
**Figure 4**  
 School House Wash near Loaves and Fishes Drive  
 Maximum Capacity about 1900 cfs

A channel was constructed along the northern edge of the Miracle Valley subdivisions to convey School House Wash by the development. Construction of this channel was apparently done with little advanced planning and design. Consequently, the channel decreases in carrying capacity as it proceeds eastward. Refer to Figures 4, 5 and 6.

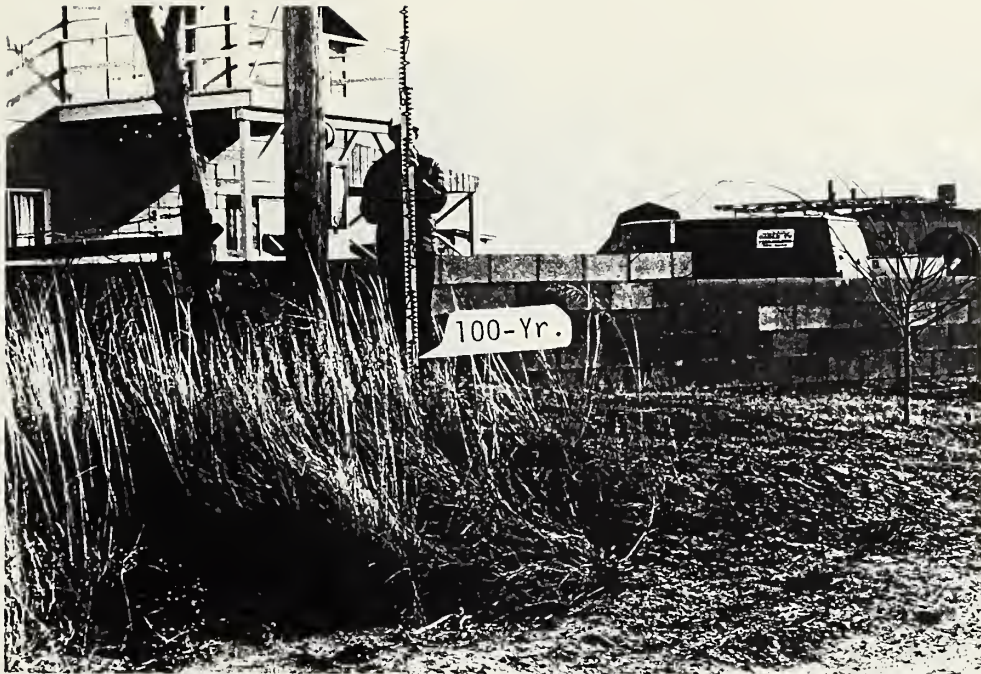
House on north side of School House Wash near junction of Third Avenue and the Wash, looking northeast. Depth, 0.7 ft.

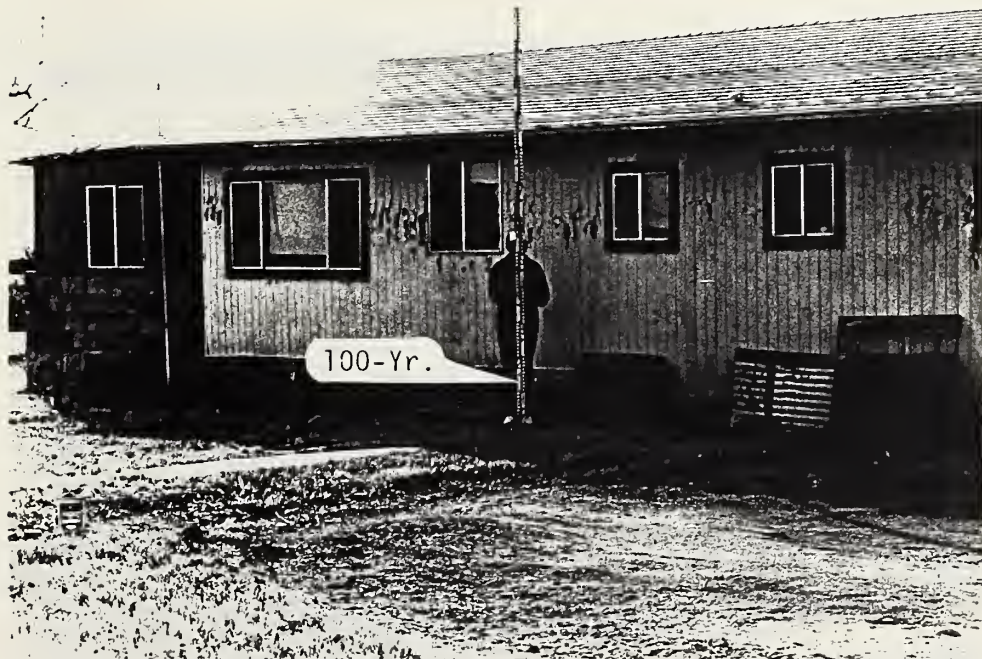
House on south side of School House Wash near junction of Third Avenue and the Wash, looking southeast. Depth, 1.3 ft.

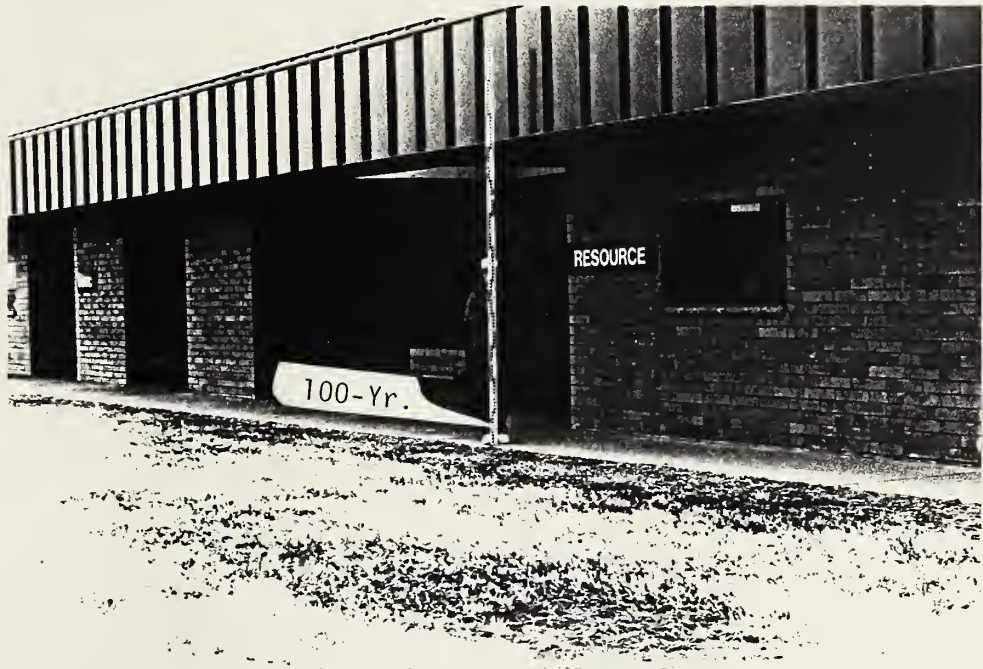
Special Education and 5th Grade Building, Palominas School Complex, looking northeast. Depth, 0.5 ft.

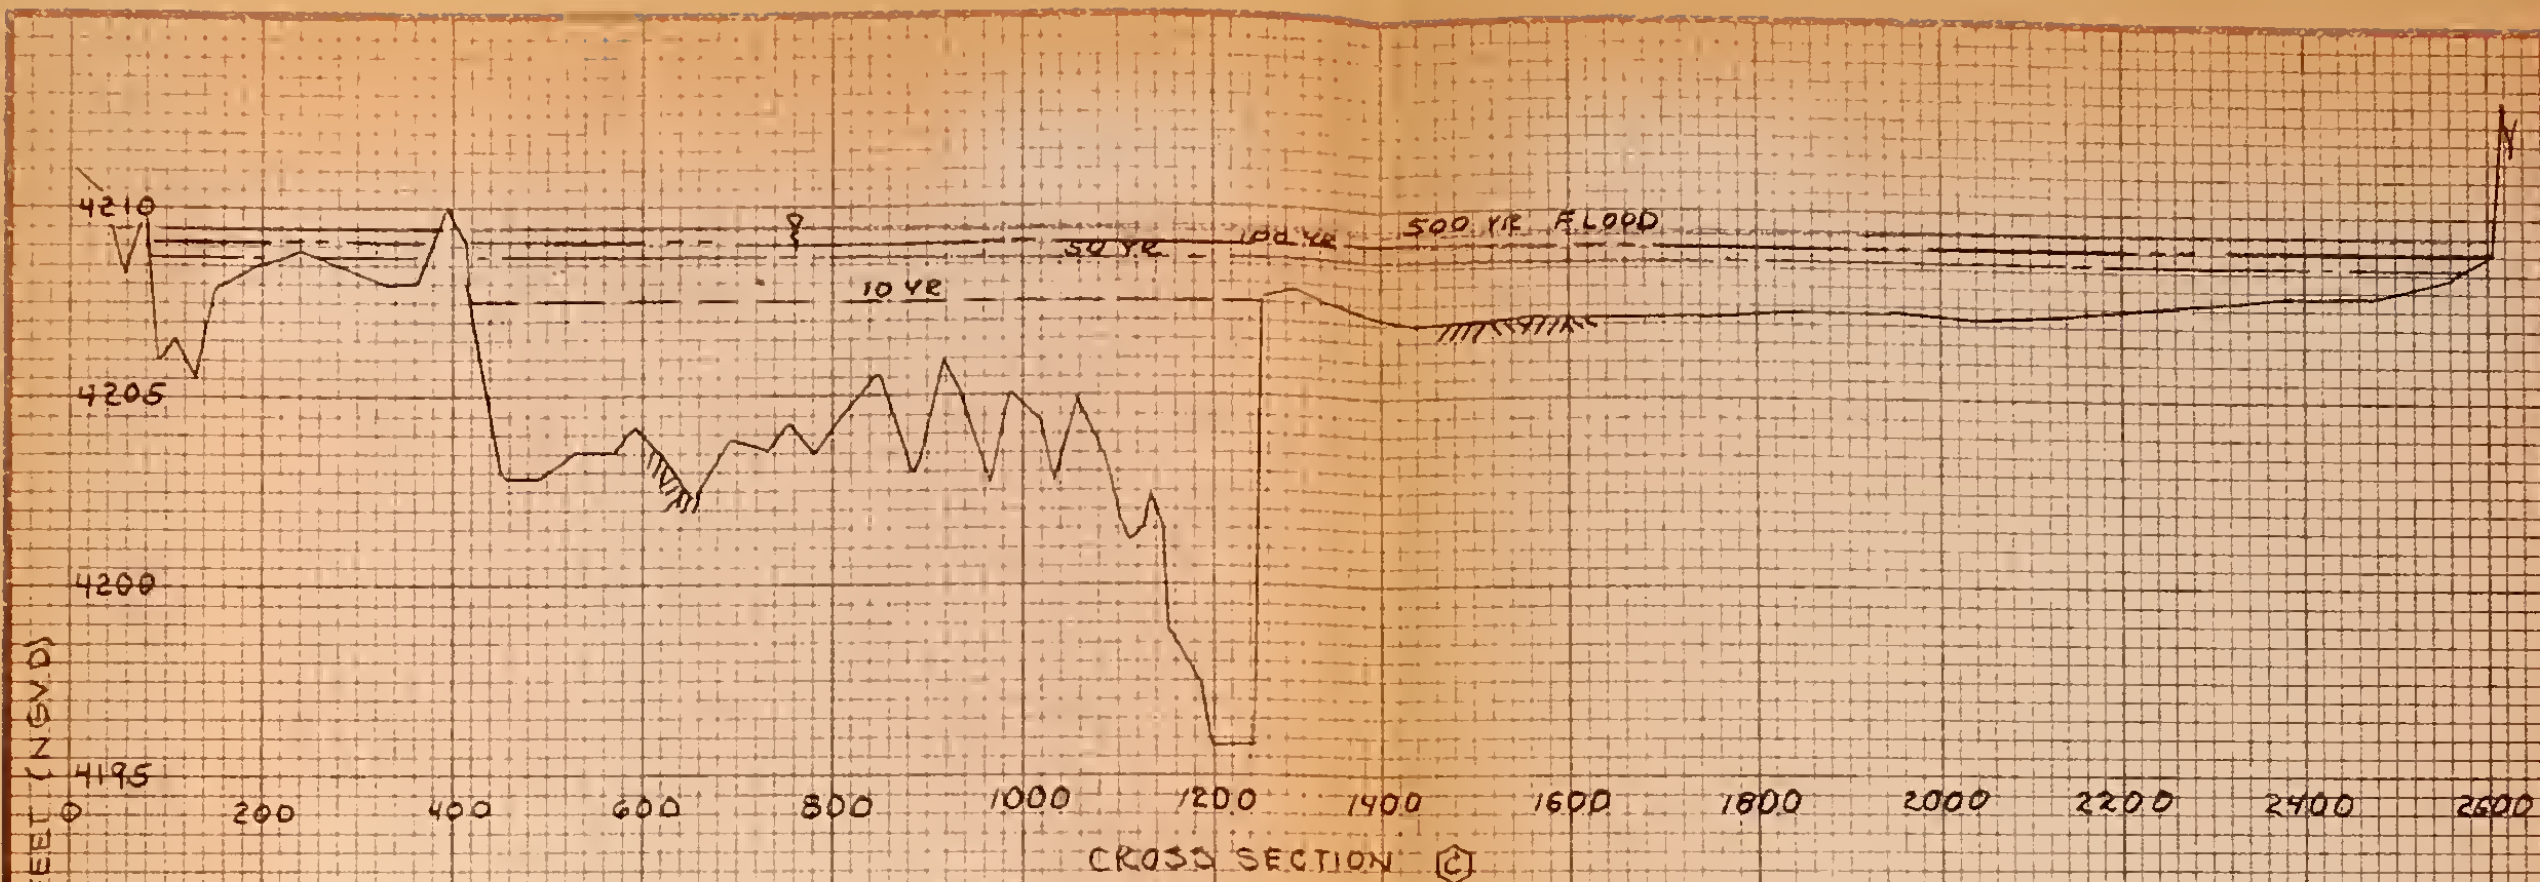
PALOMINAS-MIRACLE VALLEY FPMs  
Cochise County, AZ  
TYPICAL CROSS SECTIONS  
SAN PEDRO RIVER

SCALE  
VERTICAL 1" = 5'  
HORIZONTAL 1" = 200'
